Controlled Flight Into Terrain

Education and Training Aid

Flight Safety Foundation

U.S. Department
of Transportation
Federal Aviation
Administration

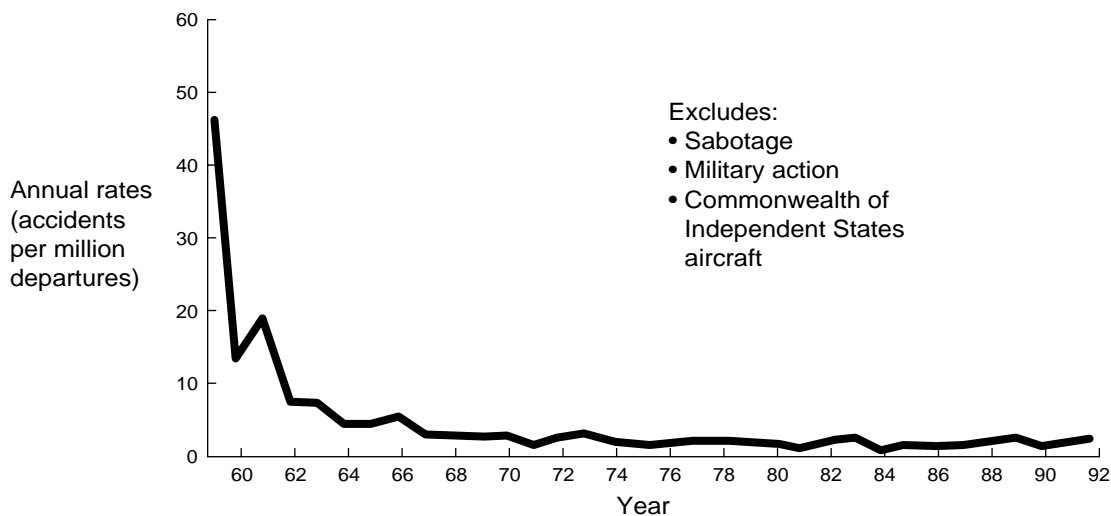
Figure 1
Hull-Loss Accidents for Worldwide Commercial Jet Fleet

The worldwide accident rate (which includes CFIT) for the commercial jet fleet decreased significantly in the 1960s and 1970s. This rate stabilized at that time and remains fairly stable today (Figure 1). Operators can be very satisfied with this accomplishment, but let's look at the actual number of CFIT accidents that are included in this accident rate. Figure 2 shows hull losses attributed to CFIT for the U.S. fleet as well as the rest of the world's fleet. The reduction in CFIT accidents that started in 1975 will be discussed later. The important thing to understand about these accidents is that

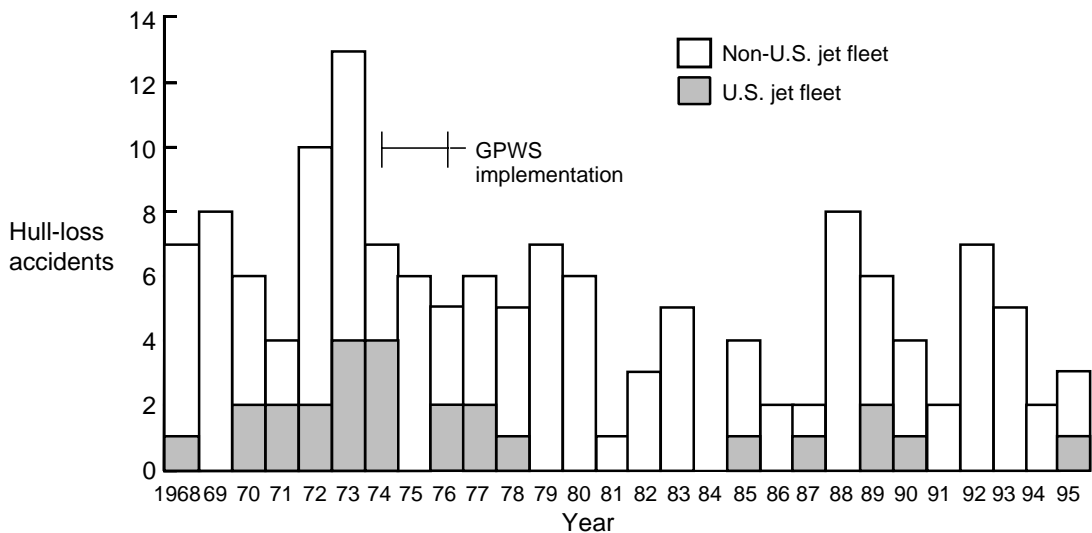
Figure 2
CFIT Hull-Loss Accidents for Worldwide Commercial Jet Fleet

The United Kingdom Civil Aviation Authority conducted an evaluation using actual airline flight data. As a result of this, in 1975 it followed the FAA lead and also mandated the installation of GPWS by issuing Specification 14 as the technical standard. The International Civil Aviation Organization (ICAO) established GPWS standards in 1979. All of these actions resulted in the reduction of the number of worldwide CFIT accidents (Figure 2).

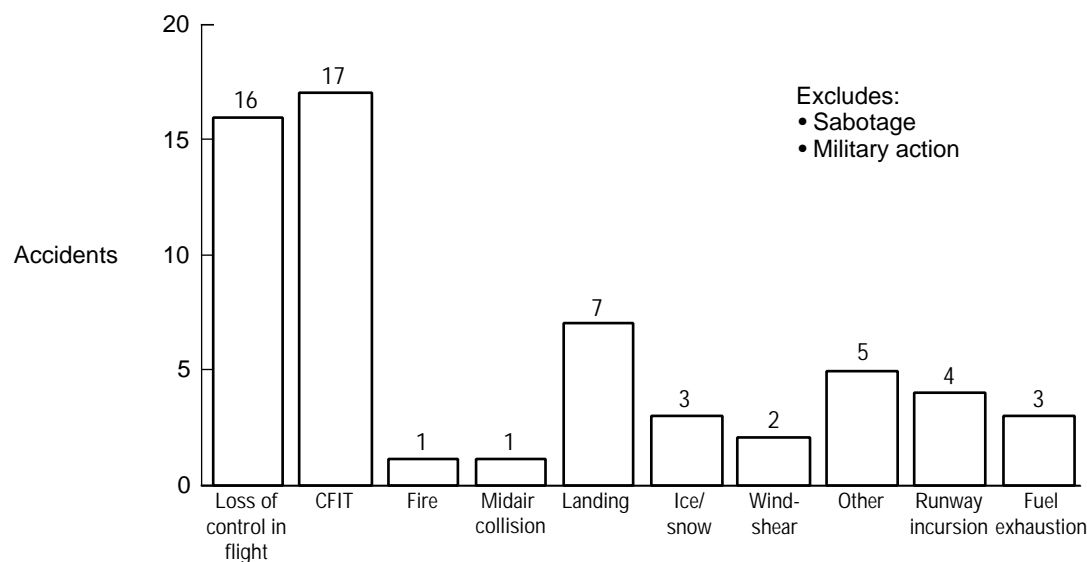
Figure 3
Worldwide Airline Accidents Classified by Type - 1991 Through 1995

they happened with normally functioning airplanes. These are accidents that operators could have prevented! From 1991 through 1995 there were more CFIT accidents than any other type (Figure 3). These accidents led to almost 1,000 fatalities, and in 1995 there were more fatalities attributed to CFIT than to any other type of accident (Figure 4). From November 1994 through December 1995, there were five CFIT accidents and 336 fatalities. CFIT is still happening.

The most prevalent primary factor for hull losses with known causes is the flight crew (Figure 9). For worldwide airlines from 1991 to 1995, there were more CFIT accidents than any other type (Figure 3). What are the causes and contributing factors for these accidents, and why do they occur? The answers lie in two areas. One set of factors is found primarily in the operations area and will be addressed in this section. Of equal importance are the factors that are present in the corporate, management, government, and regulatory area. These factors are covered in Section 2 of this CFIT Education and Training Aid.

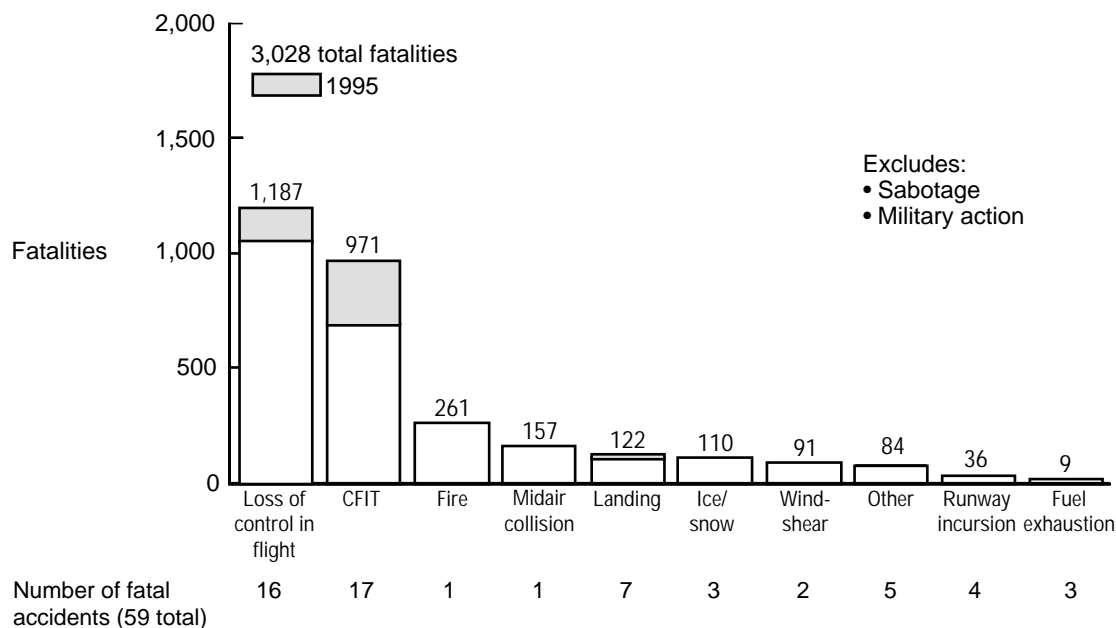
Figure 4
Worldwide Airline Fatalities Classified by Type of Accident - 1991 Through 1995

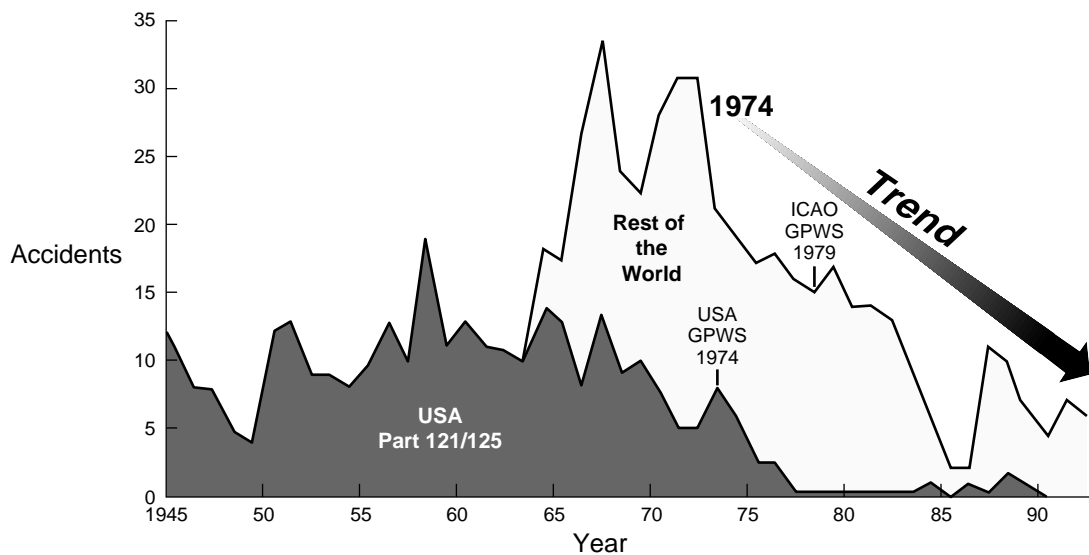
Figure 5
CFIT Accidents Per
Year—USA and
World Carriers

In 1973, some airplane manufacturers and airlines recommended that GPWS be installed on their airplanes (Figure 5). During the following year, GPWS became standard equipment on most new airplanes. The United States Federal Aviation Administration (FAA) issued a Proposed Rule requiring that GPWS equipment be installed on all airplanes that operated under Part 121 and Part 125 regulations. The FAA still had some doubts concerning the effectiveness of GPWS in preventing CFIT, and it did not want the industry to rely only on GPWS for the prevention of CFIT accidents. In fact, in early 1974, the FAA issued a statement noting that “Present instrumentation and inflight procedures provide for safe and adequate terrain clearance as long as proper flight crew members discipline is maintained and appropriate flight operations procedures are followed.”

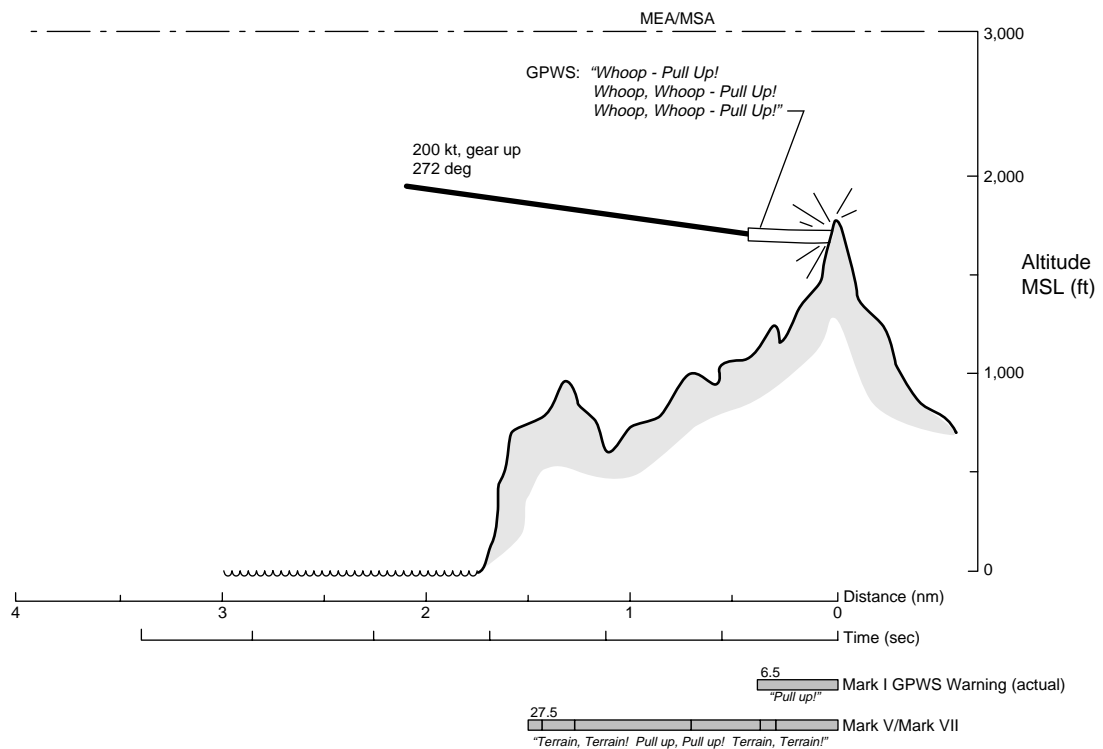
Figure 6
Flight Path Profile:
707-300, Santa
Maria, Azores,
February 8, 1989

as 5 sec warning and no warning if the projected impact point was on a relatively steep slope of a mountain. Now, after continual upgrade modifications, the warning time has increased to almost 30 sec, and improvements are still in progress. The significance of this improved warning time can be seen by reviewing the flight path profile of a CFIT accident that happened in Azores, Portugal (Figure 6).

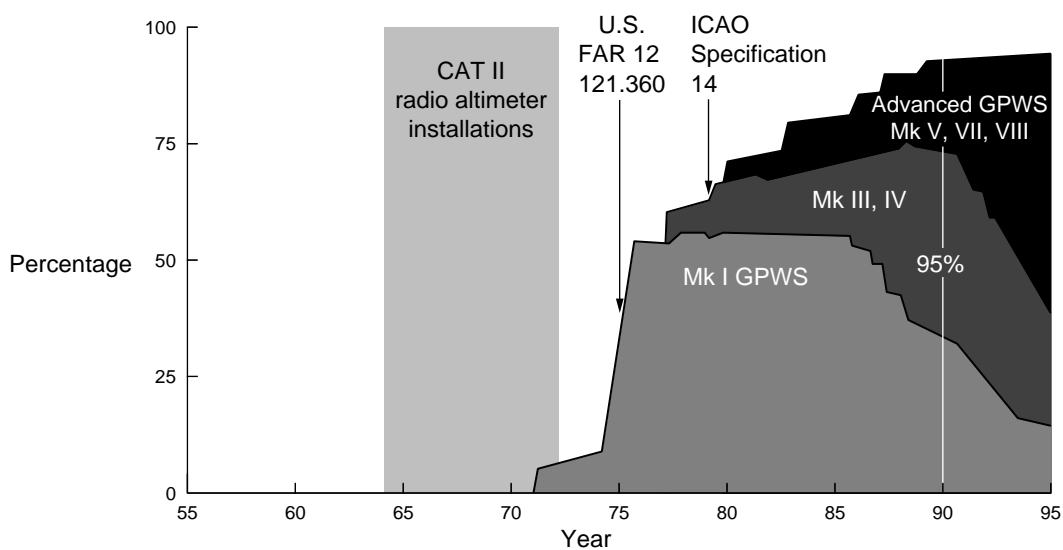
Figure 7
World Airline Jet
Fleet Equipped With
GPWS

Installation of GPWS on all airplanes should be the goal of the international aviation industry. It is estimated that over the next 15 years, half of the current unequipped airplanes will be retired from service. However, this still leaves nearly 200 airplanes that do not have GPWS installed. Currently, less than 5% of the world's commercial airplane fleet is not equipped with GPWS; however, these unequipped airplanes are involved in nearly 50% of CFIT accidents (Figures 7 and 8).

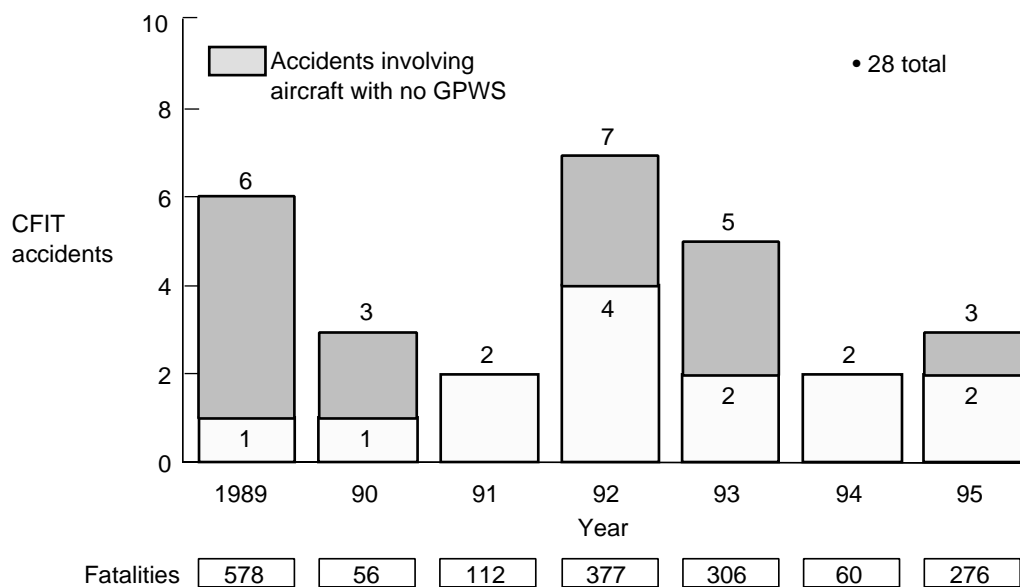
Figure 8
Commercial Jet
CFIT Accidents:
7-Year Period -
1989 Through 1995

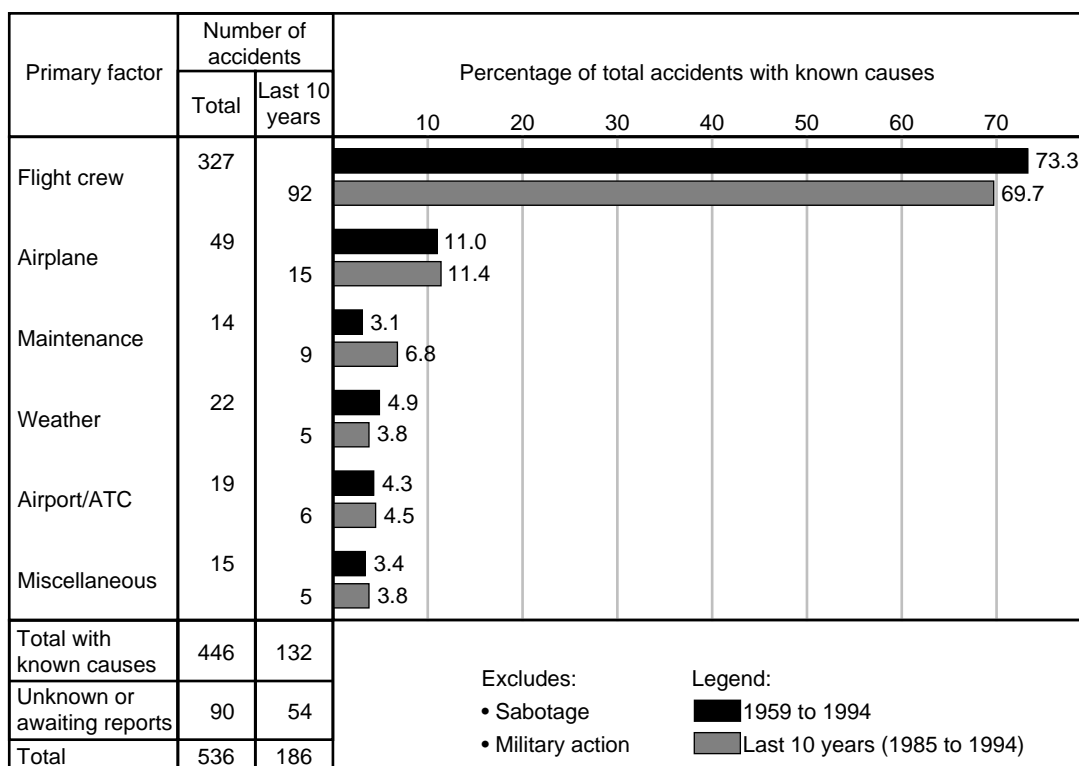
Figure 9
Primary Cause Factors for Hull-Loss Accidents for Worldwide Commercial Jet Fleet

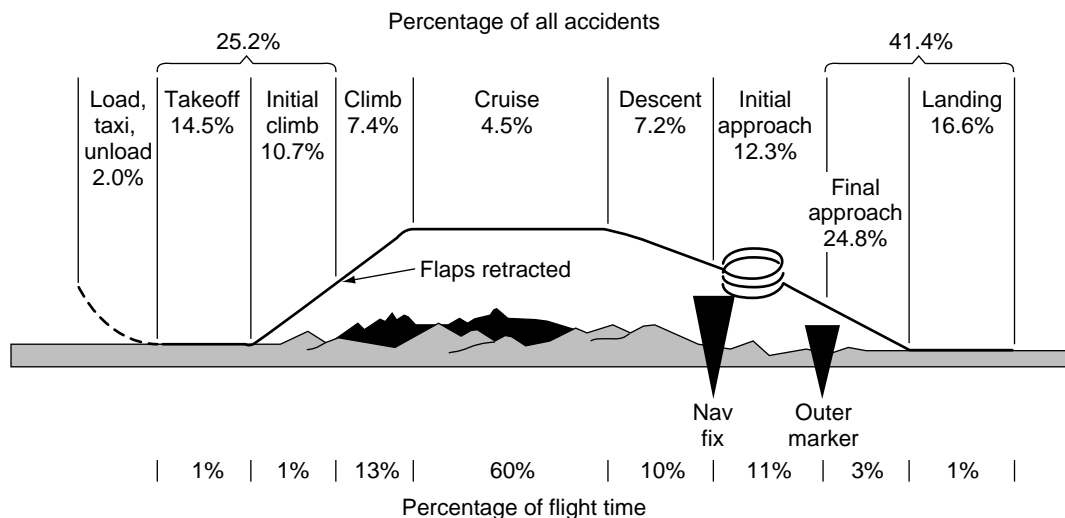
Figure 10
Percentage of All
Accidents by Phase
of Flight and the
Percentage of Flight
Time That the Flight
Crew Is Exposed
During That Phase

CFIT accidents have occurred during departures, but the overwhelming majority of accidents occur during the descent, approach, and landing phases of the flight (Figure 10). CFIT accidents make up the majority of these accidents. An enlightening analysis of 40 CFIT accidents and incidents was

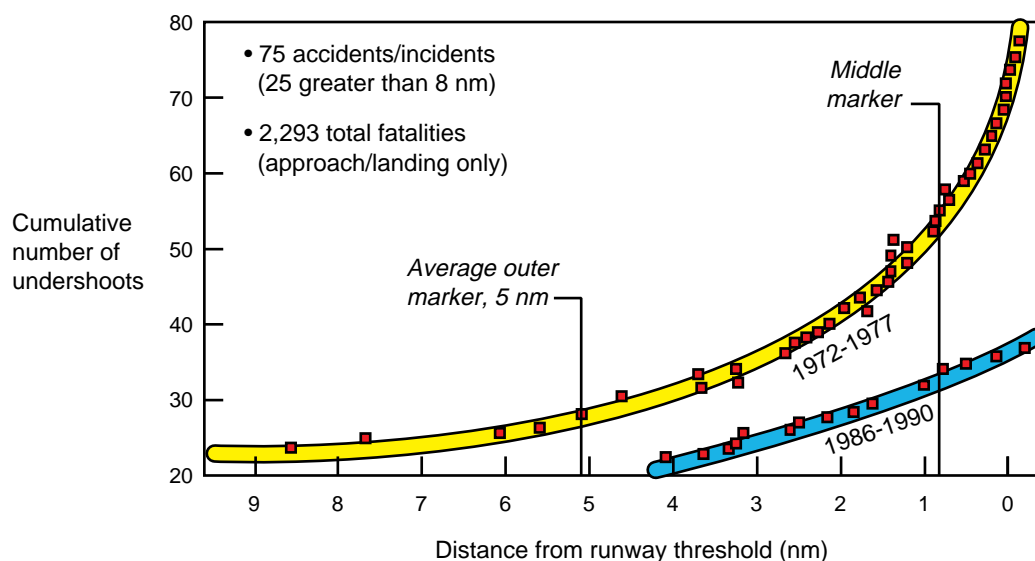
Figure 13
Geographical
Location of CFIT
Accidents

The geographical locations of CFIT accidents during the 1970s show a different pattern than those in the late 1980s and 1990s (Figure 13). During the 5-year period from 1972 through 1977, there were 75 CFIT accidents or incidents. Twenty-five of these accidents/incidents were greater than 8 nm from the runway. The preponderance of the remaining accidents/incidents were inside the middle marker. However, for the period 1986 to 1990, the distribution of accidents/incidents was relatively even. This difference may be the result of improvements made in runway approach aids that took place during this time period. Additional ILS were installed, as well as runway approach lighting systems. Continued capital investment in runway precision approach and lighting systems needs to be made worldwide.

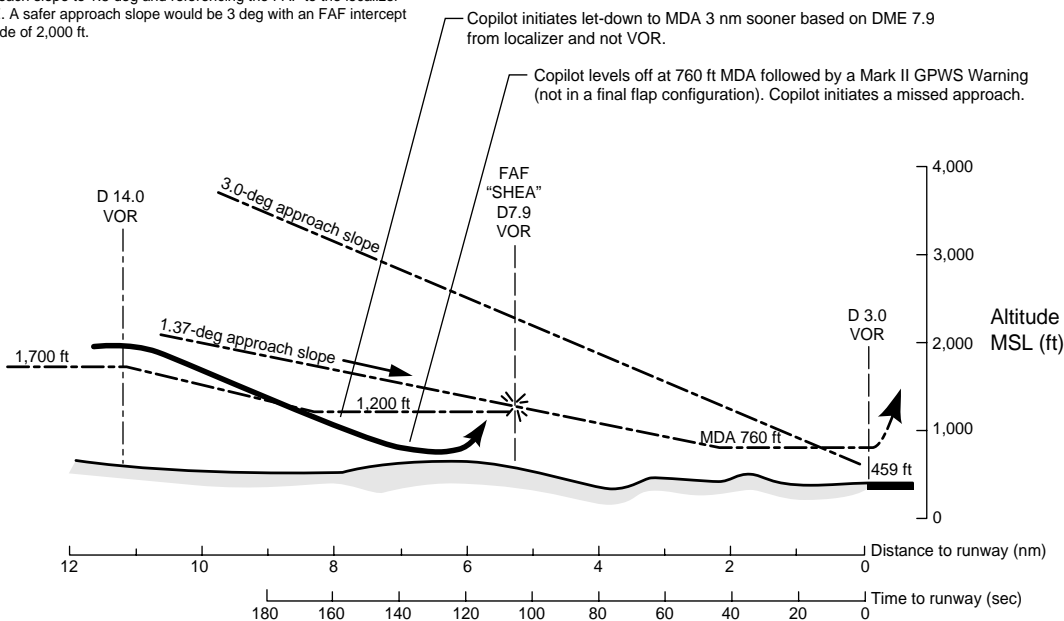
Note the very low approach slope from SHEA (the FAF) of 1.37 deg. This approach procedure has been improved since raising the approach slope to 1.5 deg and referencing the FAF to the localizer DME. A safer approach slope would be 3 deg with an FAF intercept altitude of 2,000 ft.

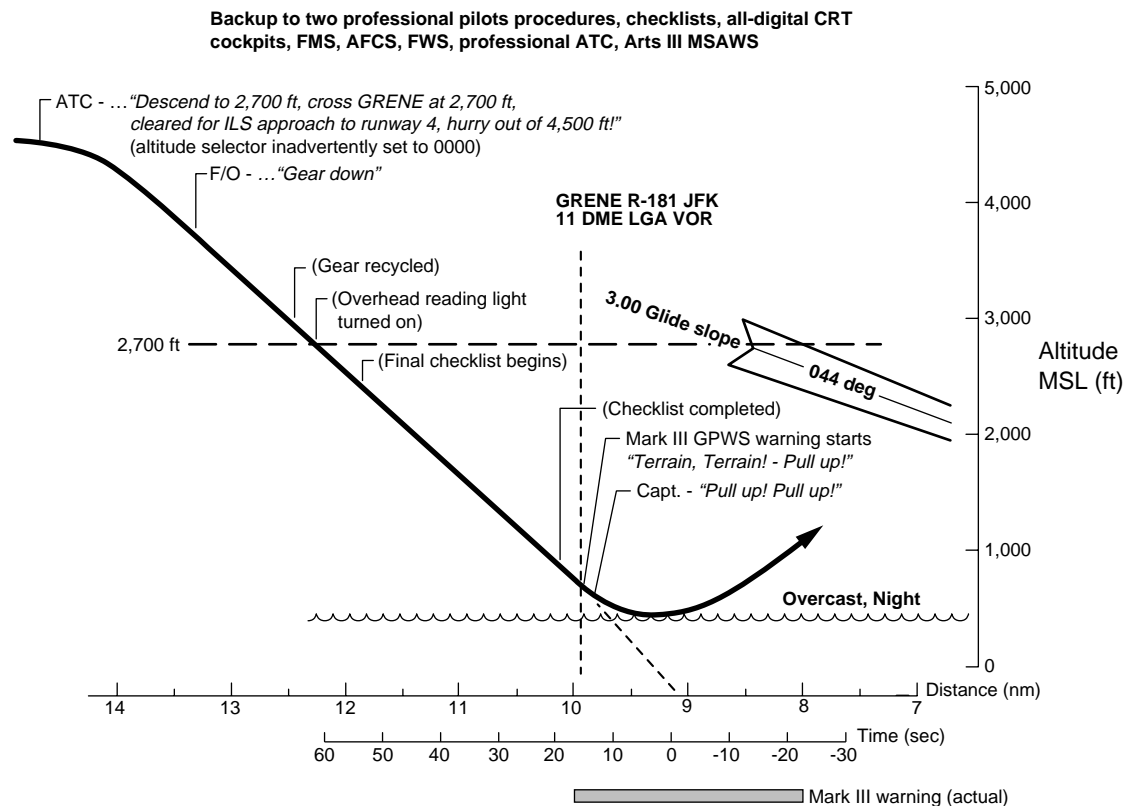
Figure 16
The Last "Safety Net": 767
La Guardia,
February 1983

“On final approach into La Guardia Airport, New York, USA, with the weather 400 foot overcast, the descent was made below the minimum maneuvering altitude. I feel that a dangerous situation existed this time, and I will try to give a history of the events (Figure 16).

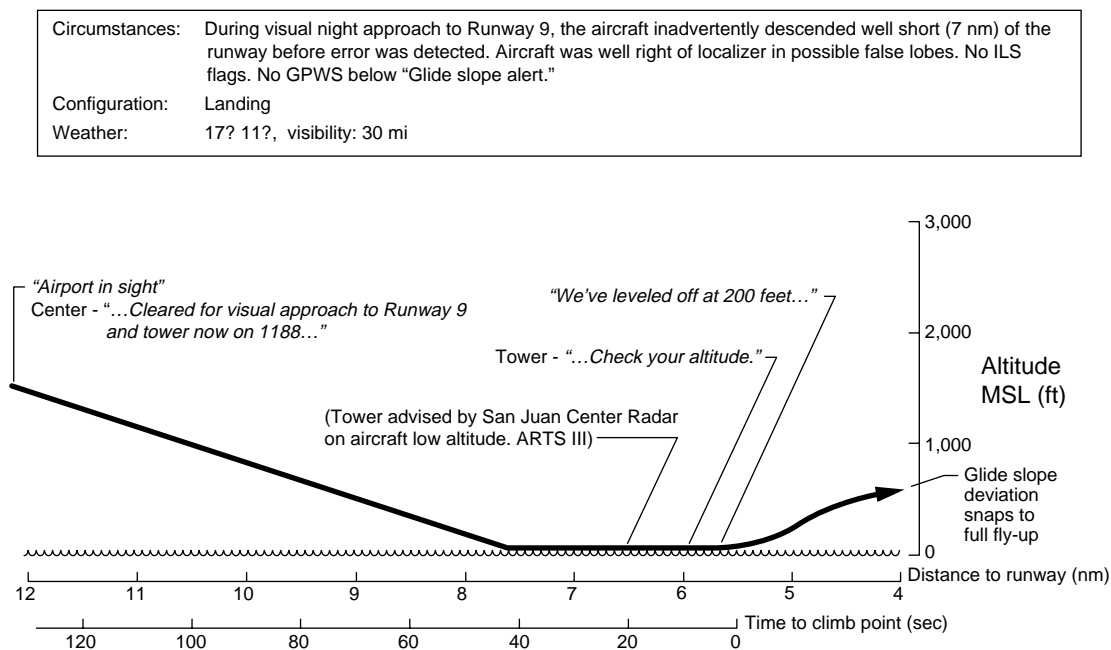
When asked about their altitude, the flight crew reported "level at 200 ft." Actually, they were 50 ft above the water and had been for almost a minute! Just after the query the airplane climbed to 600 ft. The ILS glide slope, that was previously centered, snapped to the full fly-up position. The airplane completed a normal landing.

Figure 17
Flight Path Profile

The GPWS never alerted the crew to the low glide slope because the ILS had locked on to a false lobe, and it had never alerted the flight crew to the altitude deviation because the gear was down and the flaps were in the landing position. The GPWS was operating normally, because it used inputs from the Captain's instruments that reflected an on-glide-slope condition. The GPWS never reached a limit that was considered out of tolerance.

The flight crew noticed the low altitude, but paid little attention; the tower operator could not see the airplane, but the MSAWS on the ATC center radar noticed and saved the flight! (Figure 17)

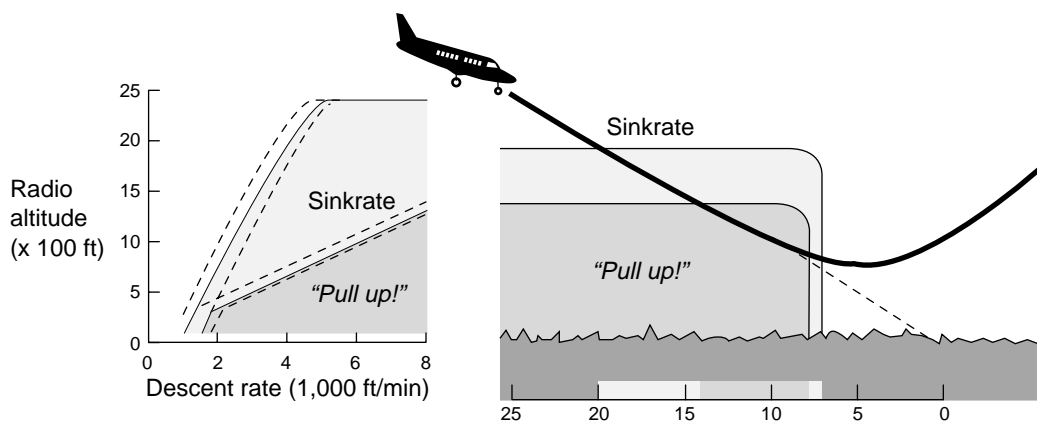
When the airplane is below a glide slope centerline, the Mode 1 sensitivity is increased. This provides additional warning time for excessive descents when below the glide slope.

Figure 1A
Mark VI GPWS
Mode 1

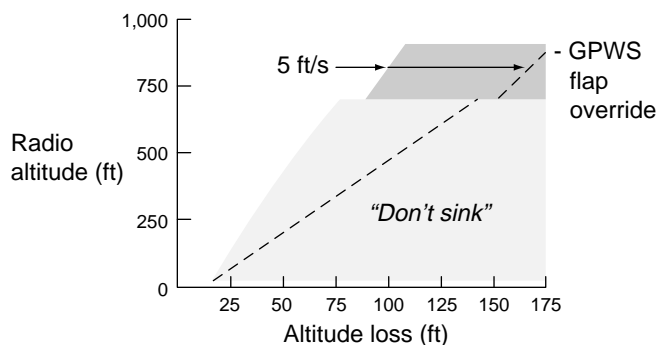
During training or special pattern work, the “GPWS Flap Override” switch may be activated above 50 ft. This will desensitize the Mode 3 alert envelope to the right, thereby allowing approximately 20% loss of Barometric Altitude before the alert is given (Figure 3A).

Figure 3A
Mark VI GPWS
Mode 3

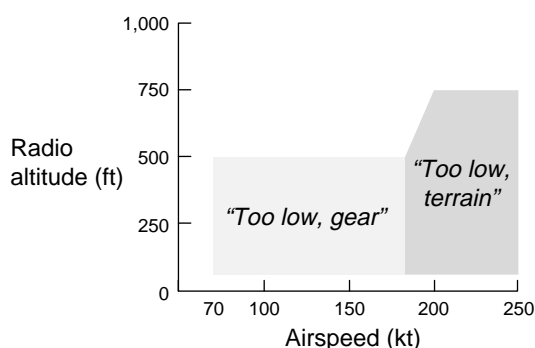
For the initial approach, at speed below 178 kt, the Mark VI monitors airplane configuration. If the airplane descends below 500 ft AGL with landing gear up, the alert “Too Low, Gear” will be given and the red GPWS Warn lamp will illuminate.

Figure 4A
Mark VI GPWS
Mode 4

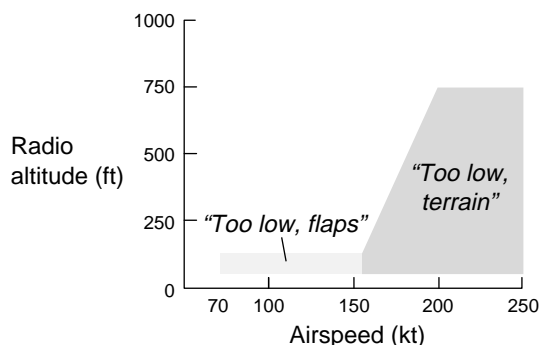
Figure 4B
Mark VI GPWS
Mode 4
Flap Override

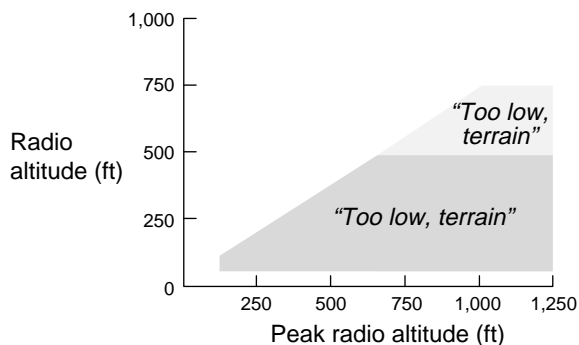
Figure 4C
Mark VI GPWS
Mode 4
Warning Floor

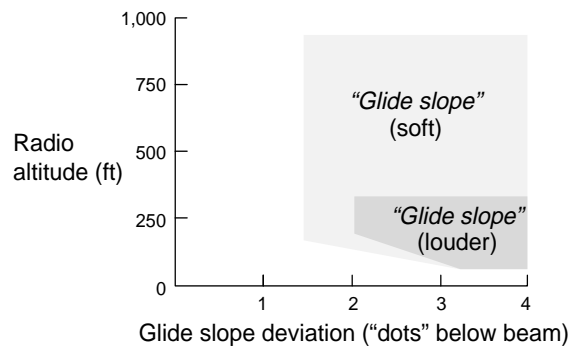
Below 150 ft of Radio Altitude, the amount of glide slope deviation required to produce an audio warning is increased to reduce nuisance warnings that could be caused by close proximity to the glide slope transmitter. Mode 5 can be inhibited by pressing the “Below Glide slope” lamp to permit deliberate descent below the glide slope in order to use the full runway under certain landing conditions.

All other warnings, except the excessive bank angle advisory, always have priority over a “Glide slope” alert. With the Mark VI GPWS computer, possible nuisances from erratic glide slope signals are automatically eliminated.

Figure 5
GPWS Mode 5

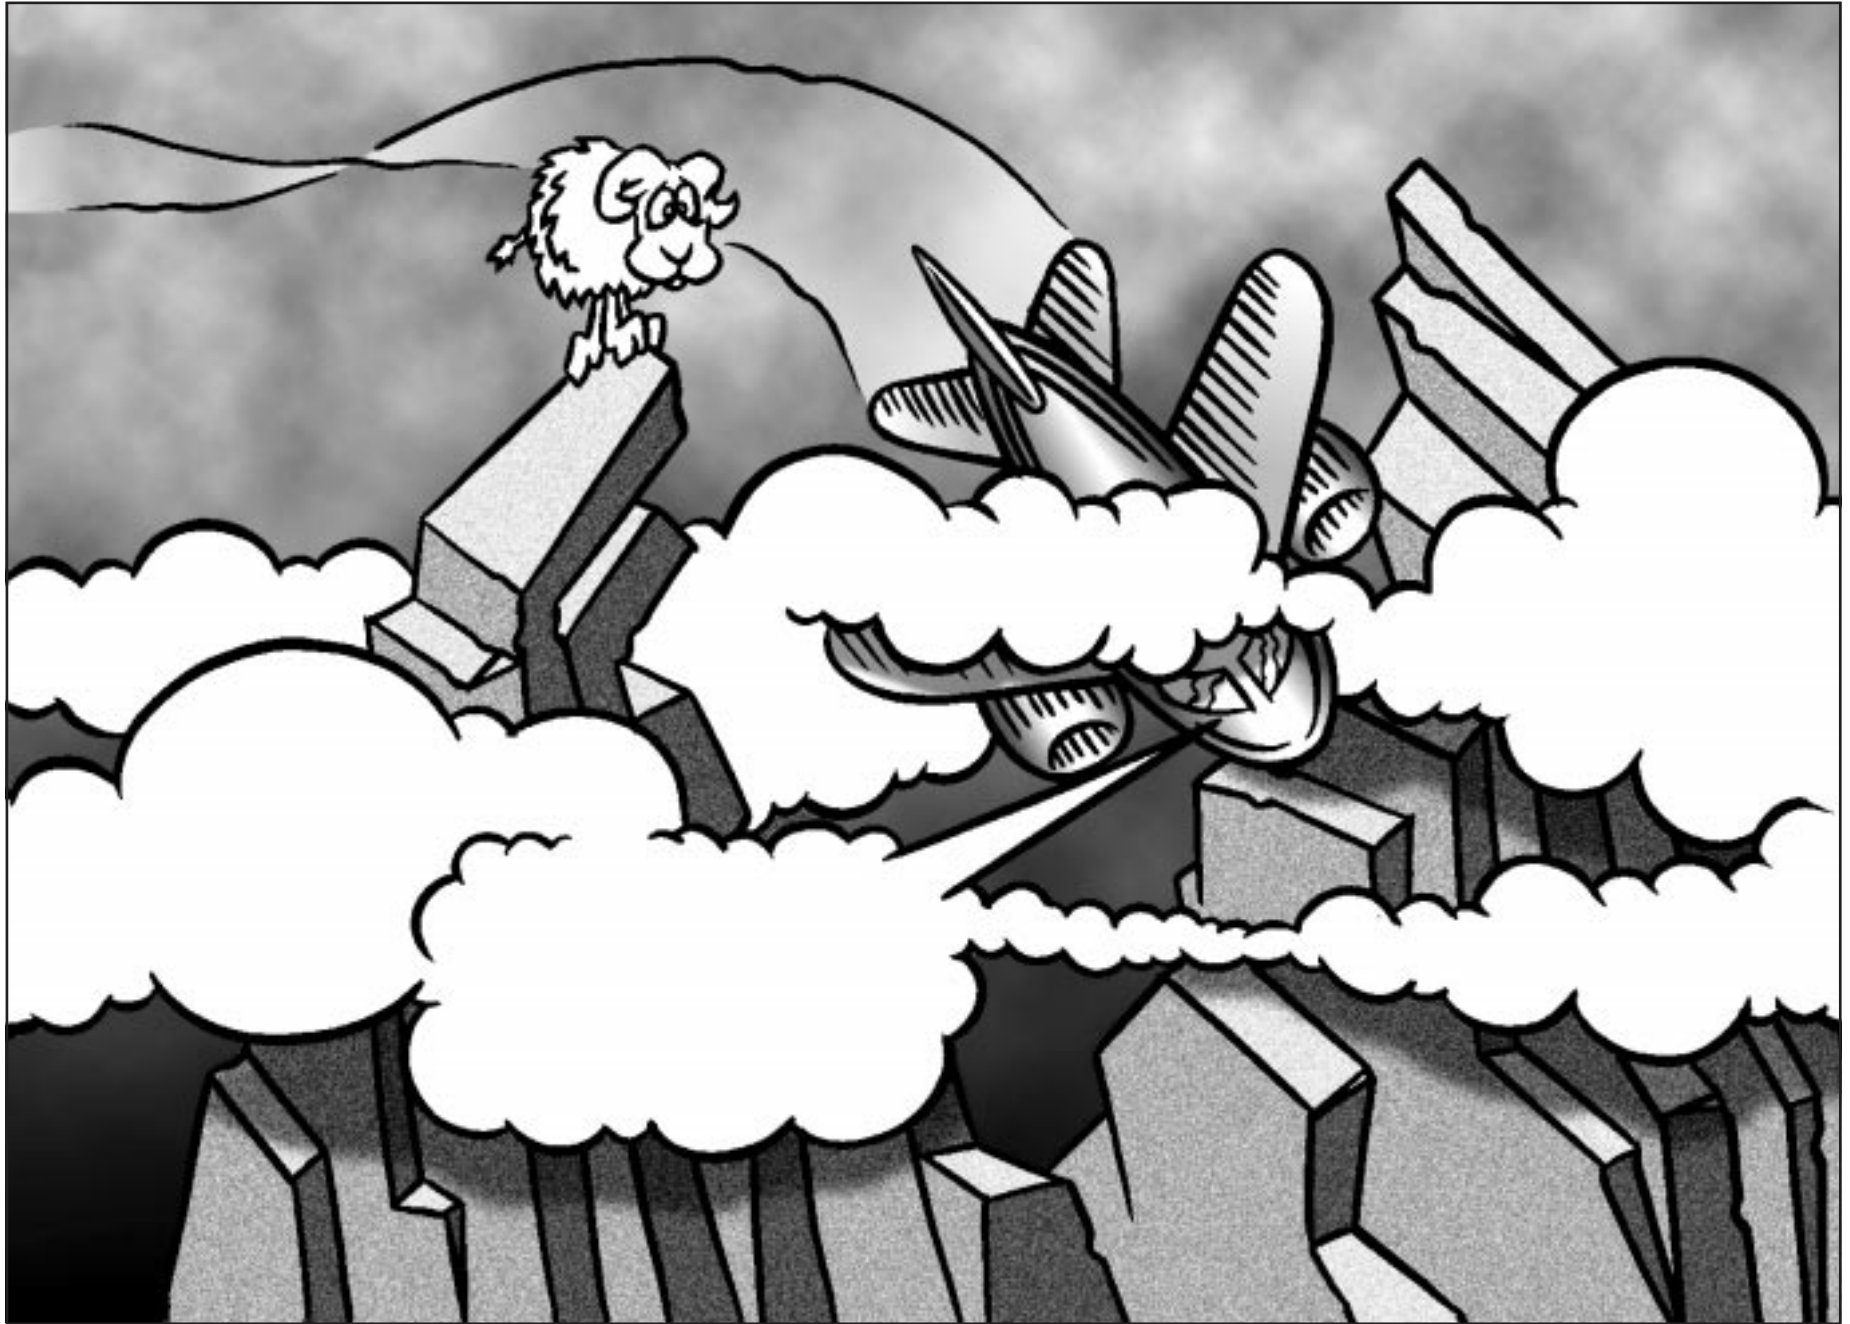
Figure 4-C.6

There are two basic causes for CFIT accidents; both involve flight crew situational awareness. (One definition of situational awareness is an accurate perception by pilots of the factors and conditions currently affecting the safe operation of the aircraft and the crew).

The causes of CFIT are the flight crews' lack of vertical position awareness or their lack of horizontal position awareness in relation to the ground, water, or an obstacle. More than two-thirds of all CFIT accidents are the result of altitude error or lack of vertical situational awareness.

Factors That Contribute to CFIT
